DEPARTMENT OF TRANSPORTATION**DIVISION OF ENGINEERING SERVICES**

Contract #: 04-0120F4Cty: SF/ALA Rte: 80 PM: 13.2/13.9File #: 69.28**WELDING INSPECTION REPORT****Resident Engineer:** Pursell, Gary**Address:** 333 Burma Road**City:** Oakland, CA 94607**Report No:** WIR-000543**Date Inspected:** 28-Sep-2007**Project Name:** SAS Superstructure**OSM Arrival Time:** 630**Prime Contractor:** American Bridge/Fluor Enterprises, a JV**OSM Departure Time:** 1530**Contractor:** Zhenhua Port Machinery Company, Ltd (ZPMC), Changxing Island **Location:** Changxing Island**CWI Name:** Ye Yong Jun**CWI Present:** Yes No**Inspected CWI report:** Yes No N/A**Rod Oven in Use:** Yes No N/A**Electrode to specification:** Yes No N/A**Weld Procedures Followed:** Yes No N/A**Qualified Welders:** Yes No N/A**Verified Joint Fit-up:** Yes No N/A**Approved Drawings:** Yes No N/A**Approved WPS:** Yes No N/A**Delayed / Cancelled:** Yes No N/A**Bridge No:** 34-0006**Component:** 114 A and 77 E**Summary of Items Observed:**

Caltrans Quality Assurance (QA) Inspector, Larry Viars was present to observe the welding of the Caltrans Mock-up #77.00 and #114.00, for the San Francisco Oakland Bay Self Anchored Suspens

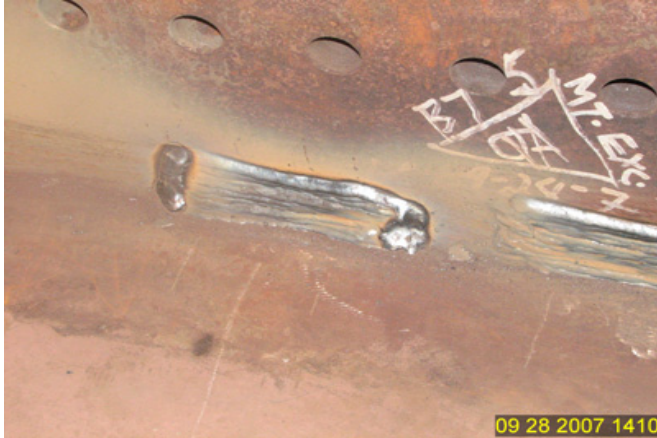
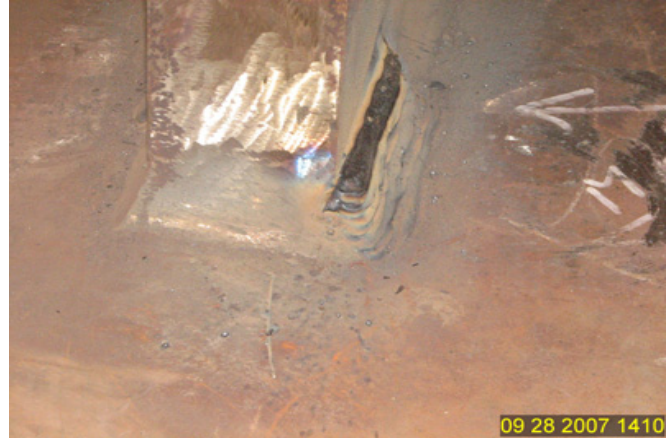
Caltrans QA Viars observed Mock-up # 114.00 Skin A sub assembly MA106 completed repair welding prior to grinding. The following observations of the repair welds are as follows. Weld # 5 had a weld bead run perpendicular to the normal welding direction at the end of the weld which would appear to make a portion of the repair in the 3G position. On repair welding of weld # 7 the termination of the welding was noted at the edge of the plate. Please see the following digital pictures below for more detail.
